**Restoring Cebolla Canyon**  
**River Ecosystem Restoration Initiative**  
**PSC #096-667-5000-0015; 2009**  
**Final Report**  
May 4, 2009-June 30, 2012

**What Was Accomplished**

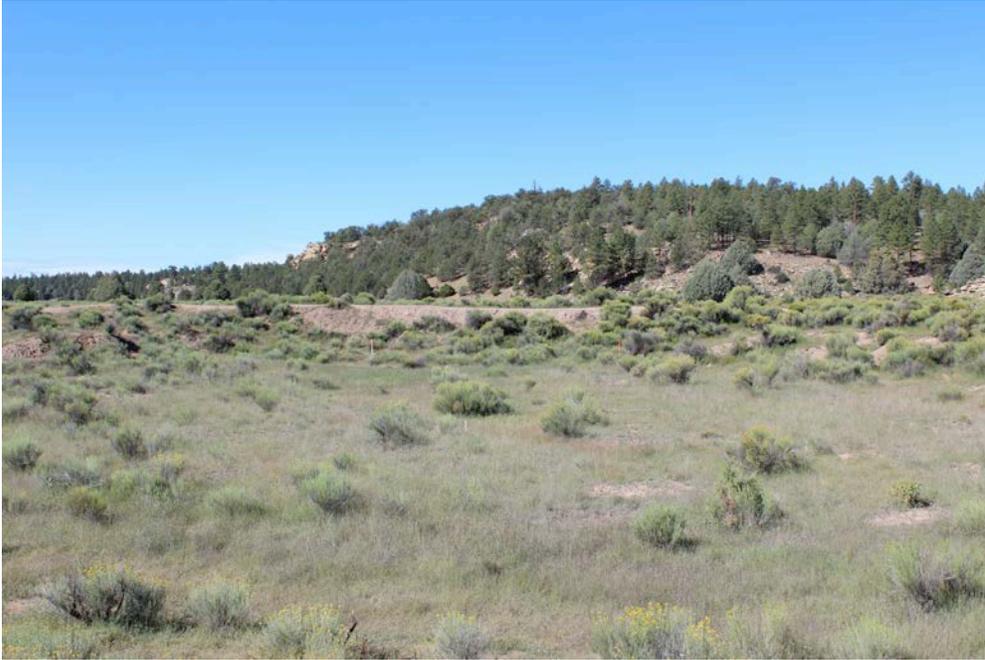
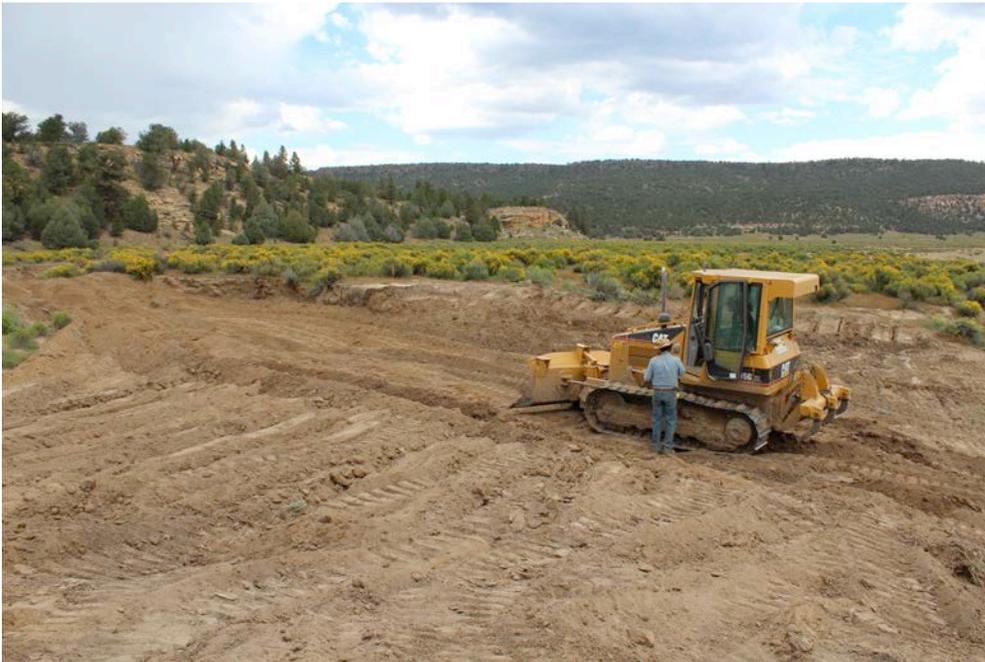
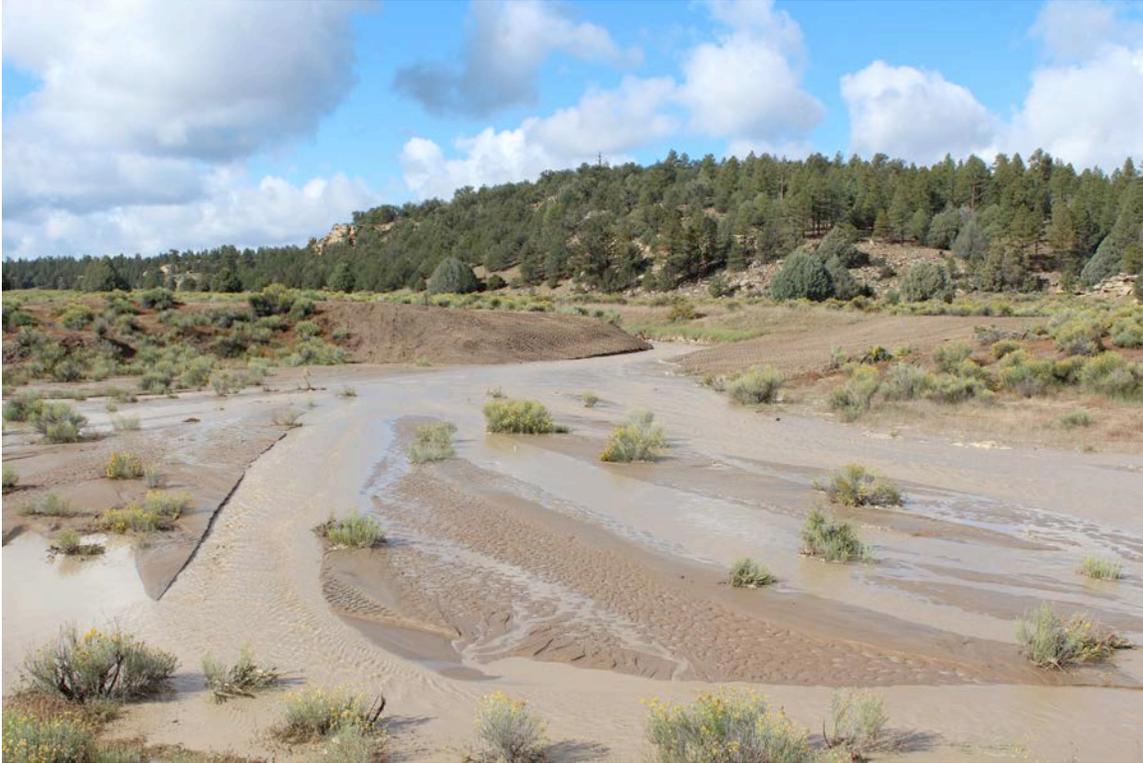
*[Top, previous page] The berm at Reach 0 before it was breached. [Bottom, previous page] During the breaching. [This page] After the berm was breached, rewetting a considerable area.*

All machine work and handwork in Reach 0 has been completed per the June 17, 2011 post-NEPA Design (Appendix E). Among other things, we breached a berm and created a new channel, did some grade control structures, plugged the existing downcut abandoned irrigation ditch and redirected stream flow via a shallow pond back into historic remnant channels on the meadow surface, constructed mini-exclosures to create a lake delta and sediment plug to create two acres of wetlands upstream in the main and side channels, and put in a number of one-rock dams to stabilize the channel bed by slowing water flow, increasing roughness, recruiting vegetation, capturing sediment, and gradually raising the bed level over time. Volunteers planted willows within the two mini-exclosures in May 2012.

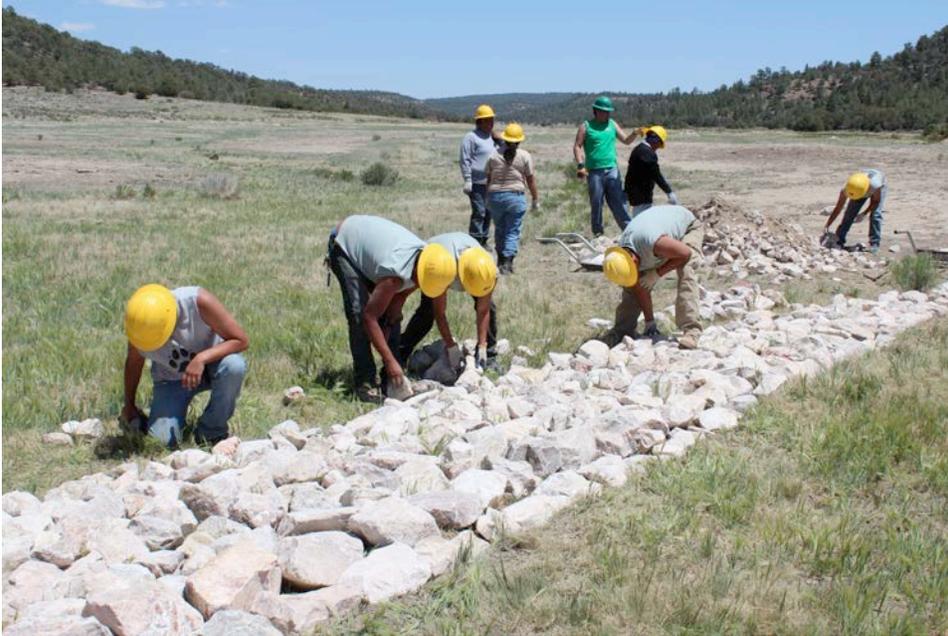
*The Acoma  
YCC crew  
working on a  
large one-rock  
dam in Reach 2  
in May 2012.*

In Reach 2, we installed three burrito dams (as originally contemplated) and eight one-rock dams, to retain spring flow on the right terrace, re-wet the terrace, form a pond fed by the spring, to raise the grade and trap sediment, and to reconnect the channel to the floodplain, thus accelerating wetland expansion.

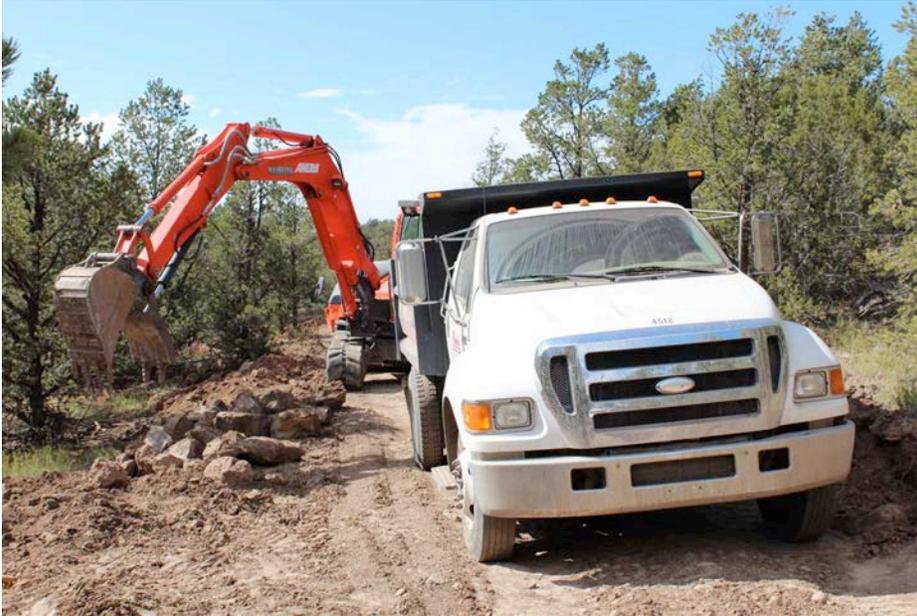
*Harvesting  
rock along  
the road.*

In addition to the equipment work, we harvested a lot of rock along the road, with permission from the BLM. The rock had been a problem in terms of getting down parts of the road and it saved us money, since we had to buy less rock. Having rock delivered was also a problem because the rain made the road very slick and muddy for some time and the rock trucks had trouble getting to the project site. We mapped out the areas where we would harvest the rock and the access routes to the project sites, and we had a BLM archeologist on site during the harvesting, to make sure we did not disturb any archeological sites. The Canyon had been extensively homesteaded in the early 20<sup>th</sup> Century and there also are a lot of much older archeological sites. Our rock inventory is included in Appendix E.

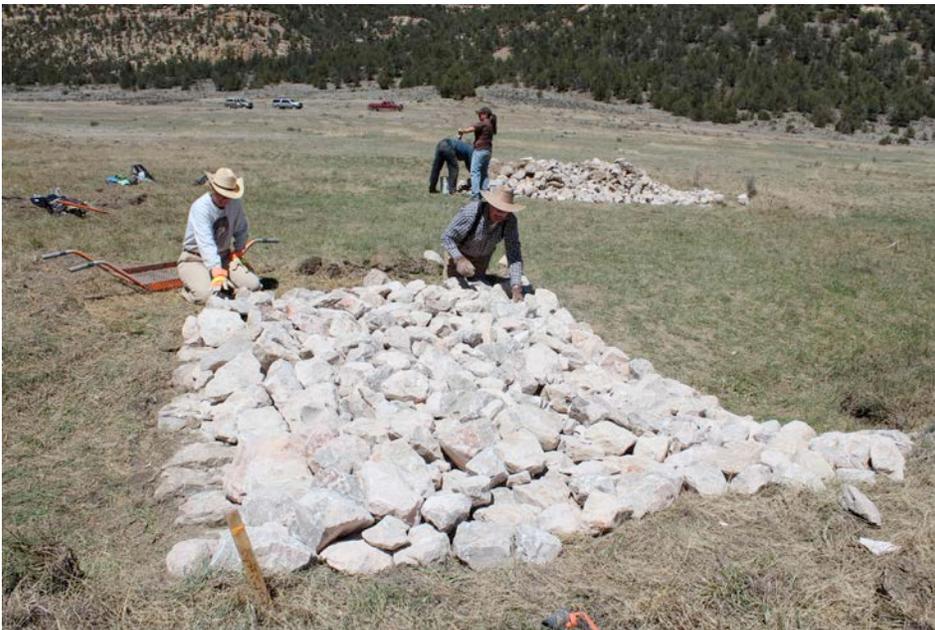
*AWF  
volunteers  
constructing a  
one-rock dam  
in April 2012.  
[Next page]  
Constructing  
the media luna  
with equipment  
last fall.*

We installed two water bars to drain abandoned roads. We installed four Zuni bowls to stabilize actively eroding headcuts and prevent headcut migration. We installed one media luna to disperse erosive channelized flow and re-establish sheet flow. We installed three one-rock dams to raise the grade and trap sediment, prevent further incision, and reconnect the channel to the floodplain. Much of this work was done with volunteers.

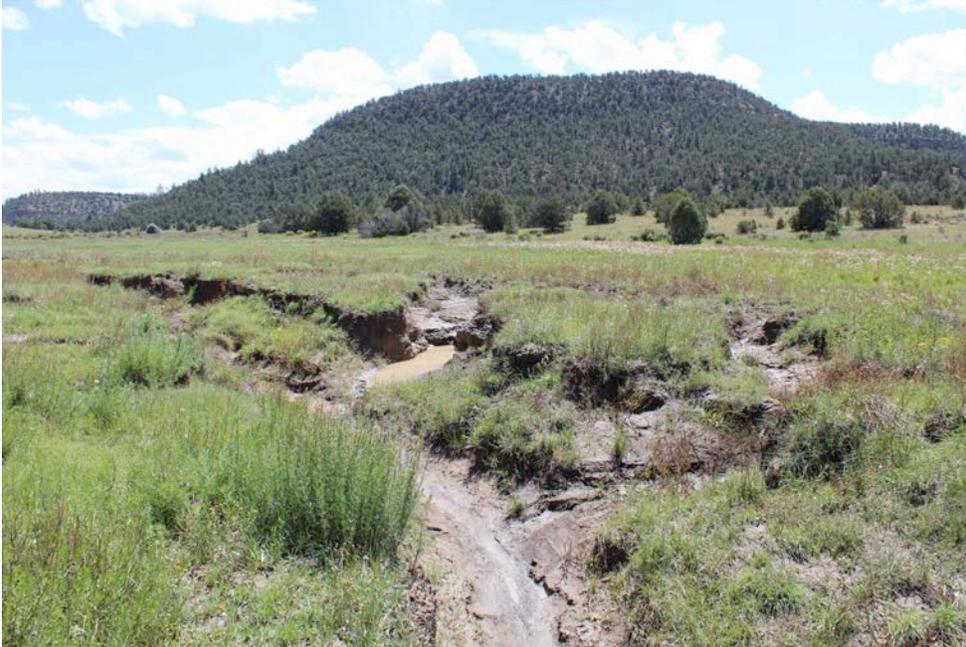
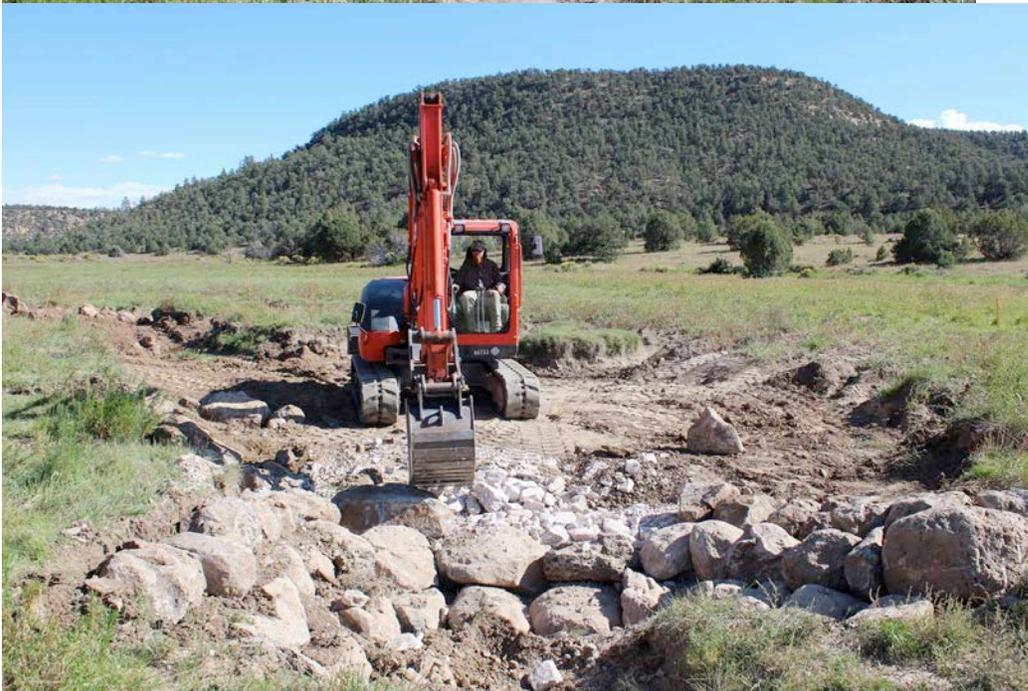
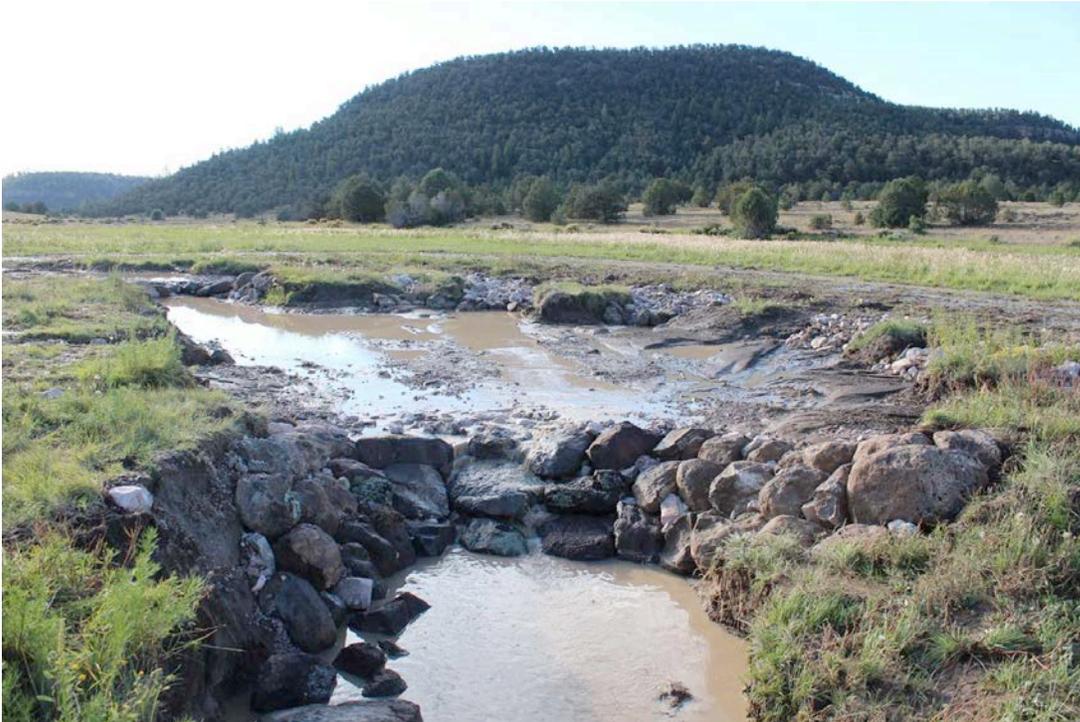
*[Top, previous page] Before work in Reach 6A. [Bottom, previous page] Craig Sponholtz working on a Zuni Bowl in Reach 6A. [This page] The finished product.*

In Reach 6A, we had to re-design our work as it originally relied on equipment work in the Wilderness Area. We installed three Zuni bowls to stabilize actively eroding headcuts and prevent headcut migration and installed 25 one-rock dams to raise the grade and trap sediment, prevent further incision, and reconnect the channel to the floodplain.

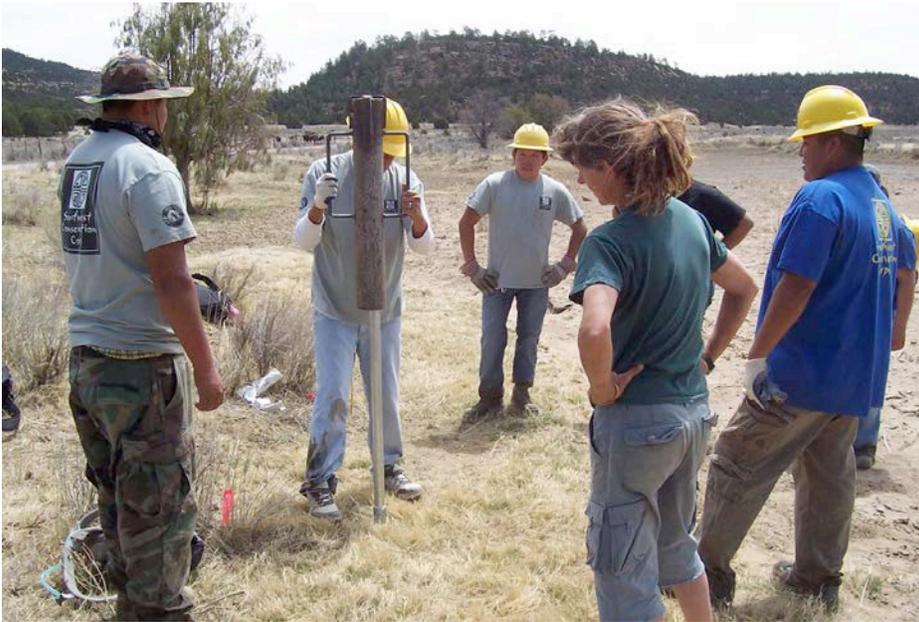
[Top] Ellen and the Acoma SCC group installing groundwater monitoring equipment.  
[Bottom] Groundwater monitoring map.

was included in the EA. Installation started at the end of May 2011 and finished in July, in part with the help of the Acoma Southwest Conservation Corps. Baseline monitoring was conducted before work started in August 2011. Further groundwater monitoring was done this Spring. A report on results so far is included in Appendix F.
